Manhole Inspection Summary

Manhole # S33YY_001MH

Insp Date: **4/16/07 11:20 AM**

Location Address: **5 LOVEGROVE ST**

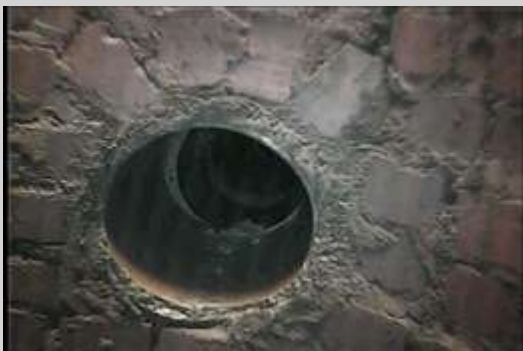
8 in. Circular Gravity Sewer Pipe In @ 6 O'Clock

Pipe Material: **Clay** ☐ Pipe Lined

Invert Depth: **8.85** (ft.) Flow Characteristics: **None**

Deposits: ☒ **None** ☐ Mud ☐ Sludge ☐ Debris ☐ Grease

Infiltration: **None** Pipe Seal Cond: **Unknown**

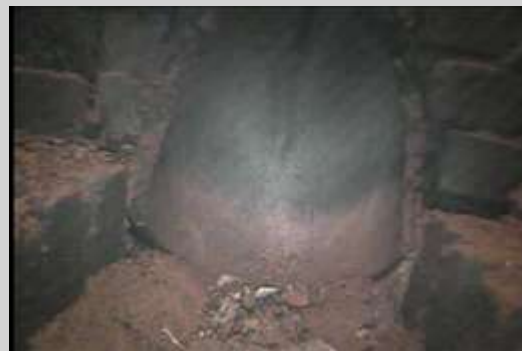
Drop In @ 6 O'Clock

Drop: **Outside** Rod and Bar

Angled: **Yes** Reading: **11.48** (ft.)

Drop Condition: **Open**
